MACHINE DATA	STATUS
No. Record	NORMAL
Nama Peralatan LUBE OIL BFPT A PUMP B	
Asset ID	
MPI	
Tanggal Test 28 JULI 2016	STANDART
Jenis Tes Running Test	Electrical Apparatus Service Association
Daya 18.5 KW	54 dB Normal
Tegangan 400 Volt	45 - 54 dB Marginal Condition
Arus Start Amps	40 - 45 dB Monitoring
Arus Normal 33.9 Amps	< 40 dB Dangerous
Rotasi 2930 RPM	
Frekuensi 50 Hz	
Jumlah Rotor Bar	
Jumlah Slot	
Jumlah Pole	
Tahanan Isolasi

EXCEPTION REPORT

RESULTS OF ROTOR BAR ANALYSIS

Area: T20 --> TURBINE 20
 Equipment: LOPBFPTAB --> BFPT A LUBE OIL PUMP B
 Meas Point: RB1 --> Current (Rotor Bar Ana.) Phase A
 Motor ID: (2 Pole) Rated RPM=2930
 Frame Size: 400 - 25 Hp Rated AMPS = 33.9
 Volts/Power: 400 - 25 Hp Rotor Bars = Unknown
 Calibration has not been performed on Measurement Point RB1.
 Percent Current Imbalance = **2.6%**

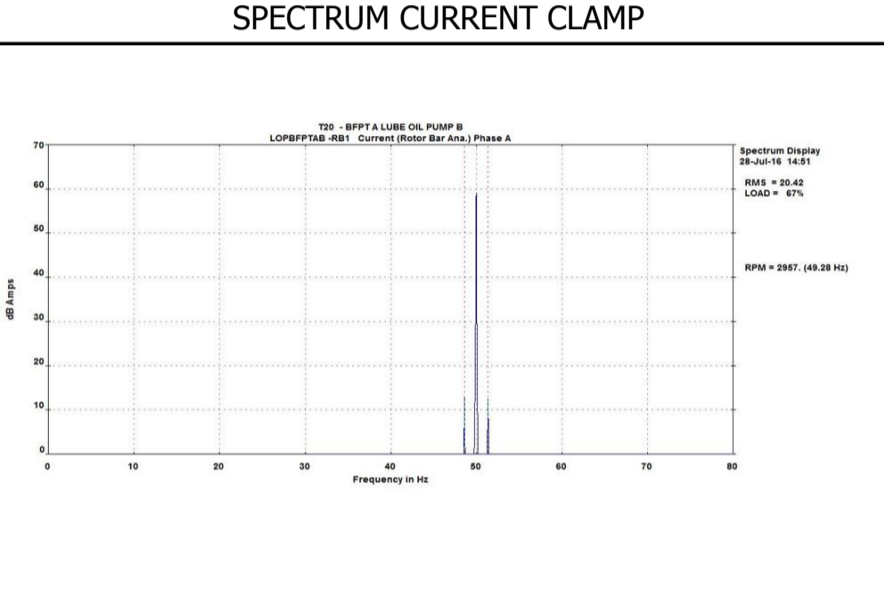
SPECTRUM	DATE	TIME	RPM	%LOAD	Amps	LF - NPxSF	SLIP	CONFD
Reference	05-Nov-14	13:41	2958	67%	18.4	48.58 Hz	.712	54%
Comparison	28-Jul-16	14:51	2957	67%	20.4	48.59 Hz	.688	61%

SPECTRUM (dB)	LF - NPxSF AMPLITUDE	LINE FREQ AMPLITUDE	CALC. DELTA	ADJUSTED DELTA	ESTIMATED % BROKEN BARS
Reference	14.24	60.00	45.76	44.09	2.0
Comparison	13.77	60.00	46.23	44.55	1.9

*** ADVISORY RECOMMENDATION ***
 Rotor Analysis indicates presence of high resistance joints.
 Watch out for progressive degradation on future analyses.

* Dari hasil pengukuran Motor Current kondisi motor dalam keadaan baik dengan nilai dB Amplitude 44.55

* Δdb 40 - 45 dB maka setidaknya ada satu broken rotor bar

* Trending pengambilan data MCSA
