Changes in Microstructure of Al/AlN Interface during Thermal Cycling

Yoshiyuki Nagatomo¹, Takeshi Kitahara¹, Toshiyuki Nagase¹,
Yoshirou Kuromitsu¹, Harini Sosiati² and Noriyuki Kuwano³

¹Central Research Institute, Mitsubishi Materials Corporation, Naka 311-0102, Japan

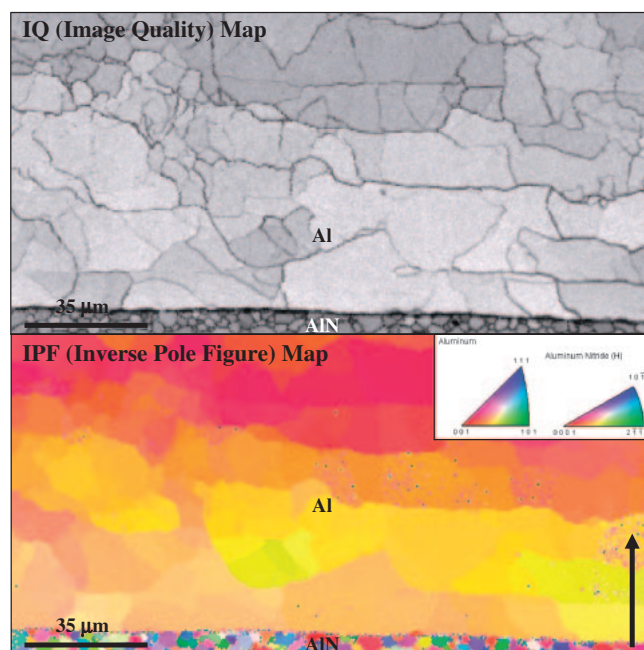
Fig. 3 IQ map and IPF map of Al/AlN interface after thermal cycle test (1000 cycles).

Figure 3 shows an image quality (IQ) map and an IPF map around Al/AlN interface after 1000 cycles. It can be seen that the cube-oriented grains are divided into sub-grains (10–50 μm) by formation of sub-boundaries. The sub-grains have almost the same direction but with a slight twisting. This result explains that the Al layer is plastically deformed with the thermal cycling.

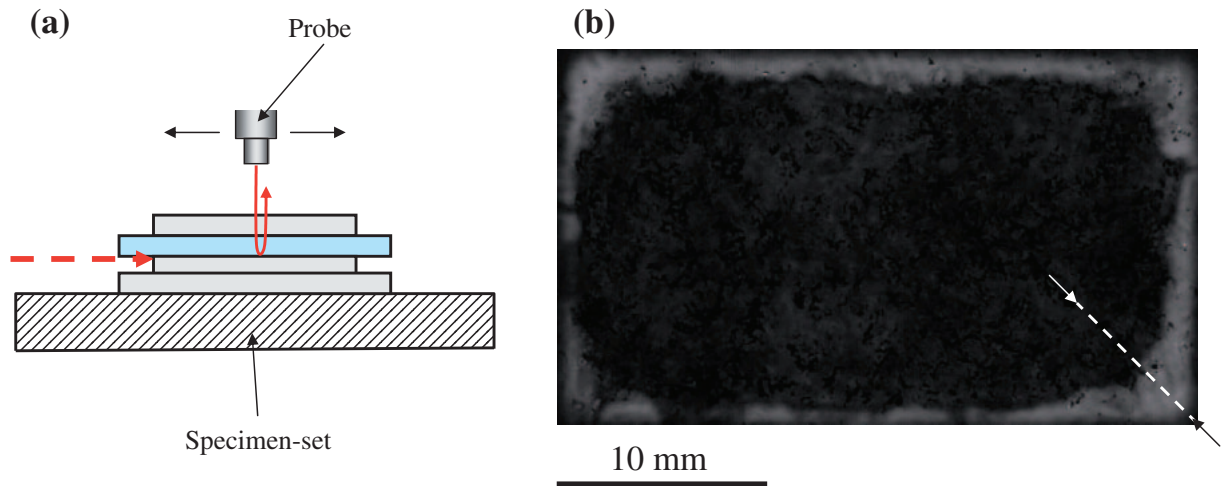
Fig. 4 Observation of the Al/AlN interface with an ultrasonic flaw detector. (a): Schematic of observation condition and (b): Flaw image of the Al/AlN interface pointed with the arrow in (a). Specimen for cross-section observation was prepared with cutting along the broken line in (b).

Figure 4 shows an ultra-sonic flaw image of the Al/AlN interface after thermal cycle test (4000 cycles). In this image, the brighter area indicates a propagating fracture. The fracture generated from an edge of Al after approximately 2000 cycles, and propagated to the center progressively. The propagation was faster at the corners of Al plate than that along the sides. It was considered that the faster propagation is attributable to a larger concentration of stress at the corner.

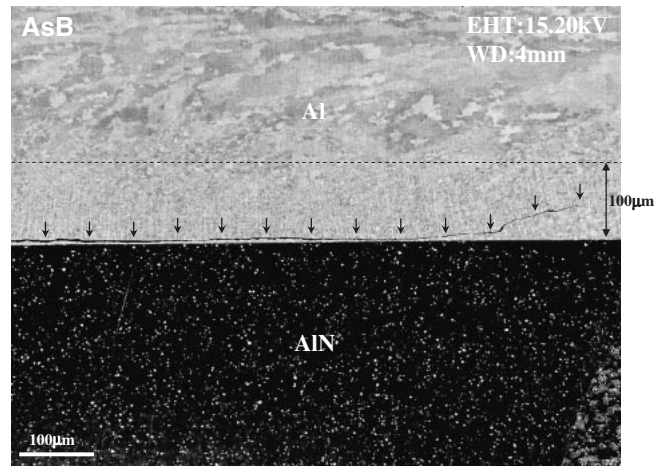
Specimens for cross sectional SEM observation of the fracture area were prepared by cutting along the broken line remarked in Fig. 4, where the fracture propagation rate was expected to be faster. Figure 5 shows an AsB image of the specimen above-described and Fig. 6 shows an enlarged AsB image around the Al/AlN interface including a fracture termination. Brighter areas in Fig. 5 and Fig. 6 are of an Al layer. The arrows in Fig. 5 indicate a propagating fracture observed with an ultra-sonic flaw detector. It can be seen that a crack is running inside the Al layer at a distance of 10 μm or less from the Al/AlN interface. Al grains are clearly observed in the Al layer thanks to diffraction contrast. It could be seen that Al grains had changed to be much smaller grain size of less than approximately 3 μm . The decrease in the grain size of Al near the Al/AlN interface was especially remarkable and the fine-grained Al area reached approximately 100 μm in width from the Al/AlN interface (Fig. 6). It was considered that the alternating plastic strains in Al layer were accumulated in the region near the Al/AlN interface, as explained with the FEM analysis (Fig. 7).

Fig. 5 SEM-AsB image of Al/AlN interface after thermal cycle test. Arrows show the crack in Al layer.

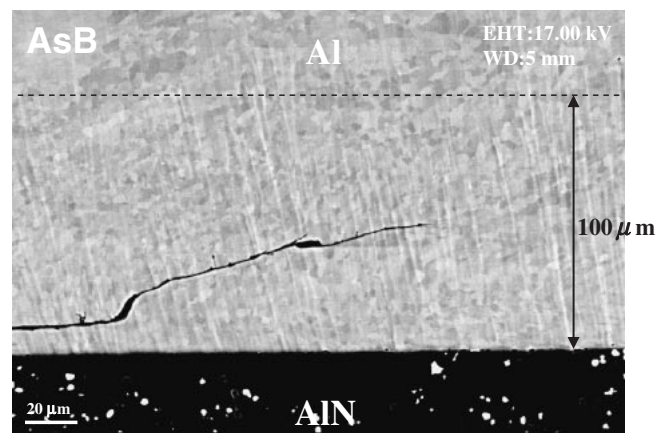
Fig. 6 SEM-AsB image of crack in Al layer.

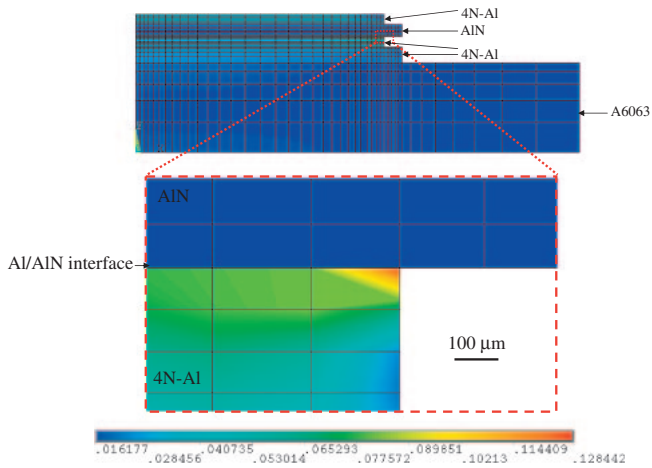
Fig. 7 Result of FEM analysis of thermal cycle test. Contour shows distribution of plastic strains in Al layer after thermal cycling (3 cycles).

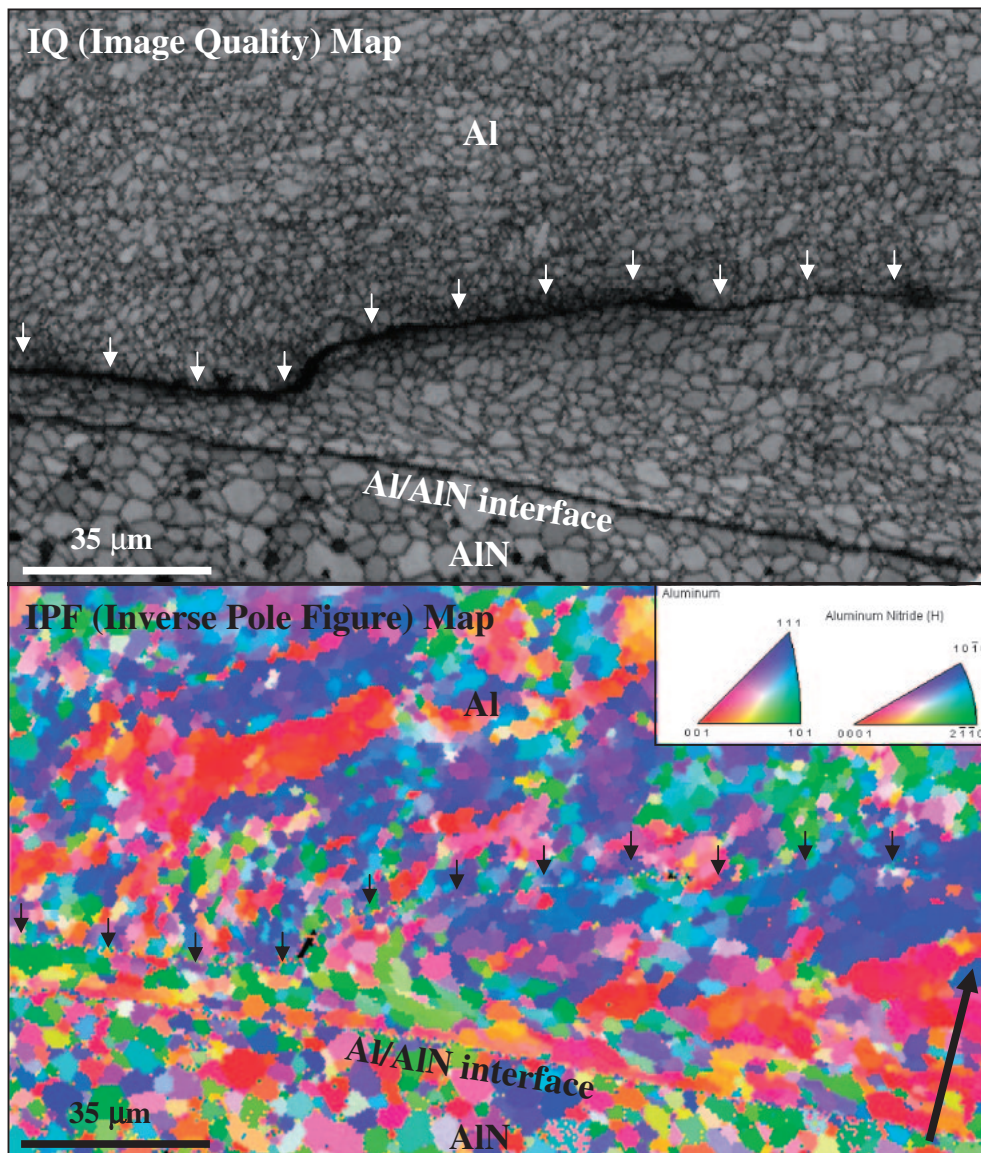
Figure 8 shows the IQ map and IPF map of EBSD analysis around a crack tip. It is revealed that the cube orientation disappeared in the fine-grained Al region. In addition, fine-grains of Al close to the crack tend to have the crystal-orientation of $\langle 111 \rangle_{\text{Al}}$ in the direction of the arrow in Fig. 8. It is considered that the shear strain due to the thermal cycling caused the alignment of $\{111\}_{\text{Al}}$ plane, which is the slip plane

Fig. 8 IQ map and IPF map of Al/AlN interface including a tip of the crack.

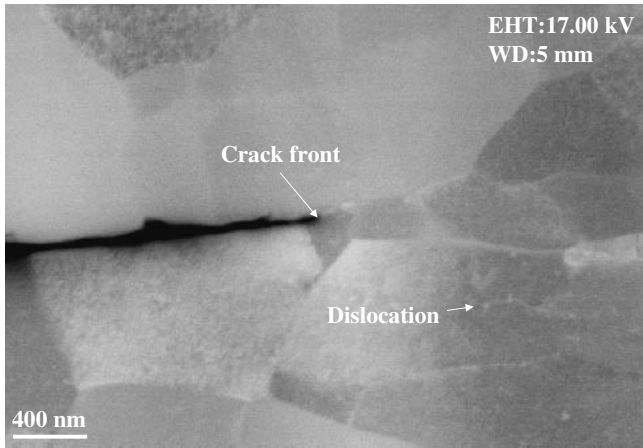
of FCC structure. In the AsB image of higher magnification, it can be seen that the crack propagated along the grain boundaries in the fine-grained Al (Fig. 9). The Al grains at

the crack tip reduced their size to be 0.2–1.0 μm. The contrast in AsB images is similar to the diffraction contrast observed in TEM because AsB detected the backscattered electrons that are strongly related with channeling and diffraction. Figure 9 shows that the diffraction contrast caused by strain arising from dislocations and sub-grain boundaries can be found in the Al with AsB observation.

Fig. 9 SEM-AsB image of tip of crack in Al layer. Al grains are observed clearly with diffraction contrast.

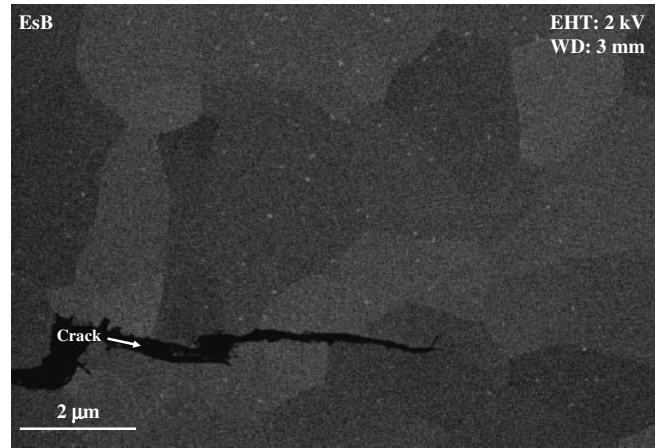
Figure 10 shows an EsB image around the crack tip observed with a low accelerating voltage (2 kV). It can be seen that particles which have a brighter Z contrast than that of the Al matrix are precipitated in the Al layer. An EDX analysis revealed that an element of the particles consisted mainly of Si. Since the Si particles cannot be observed before the thermal cycle test, the Si particles are expected to be precipitated during the thermal cycling.

Fig. 10 SEM-EsB image around the tip of a crack in the Al layer. Si particles are observed in the Al matrix with a Z contrast.

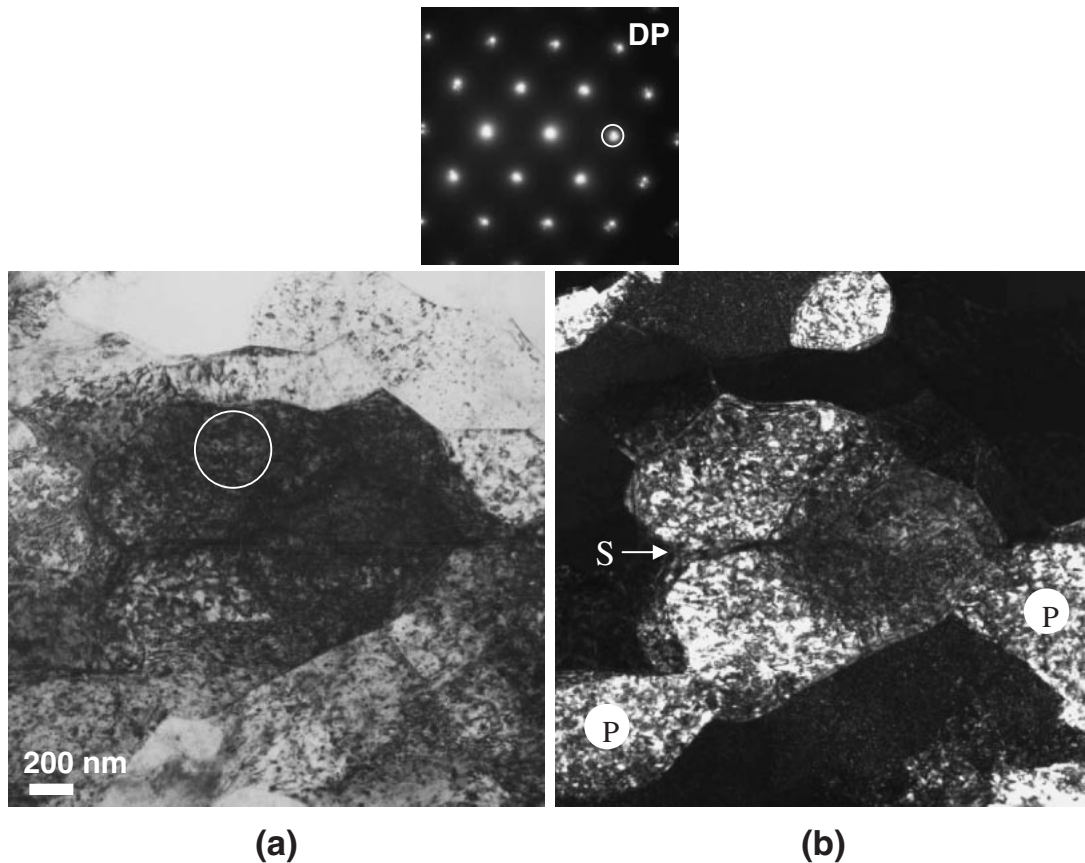
Fig. 11 Diffraction pattern of the area indicated with the circle in (a) and TEM images of Al nearby tip of crack after thermal cycle test. (a): bright field image and (b): dark field image.

TEM observation of the microstructure near a crack in another specimen was carried out in order to investigate the mechanism of the refinement of Al grains and the crack propagation. Figure 11 shows the results of TEM observation of the Al near the crack prepared with FIB micro-sampling. Figures 11(a) and (b) show a bright field image and a dark field image obtained with $hkl = 200$ diffraction spot, respectively. It can be seen that the sub-boundary was formed

laterally (in $\langle 100 \rangle_{\text{Al}}$ direction of this grain) with dislocations bundled in the grain. The grain was bruised at the right side pointed with the arrow of “S”, and the grain was about to be divided into an upper and a lower parts. At the same time, the grains oriented in the almost same direction were connected from each other to become the laterally elongated grains as shown with “P”. These results revealed that generation and accumulation of dislocations caused the refinement of Al grains. The accumulation of dislocations causes crack formation eventually.

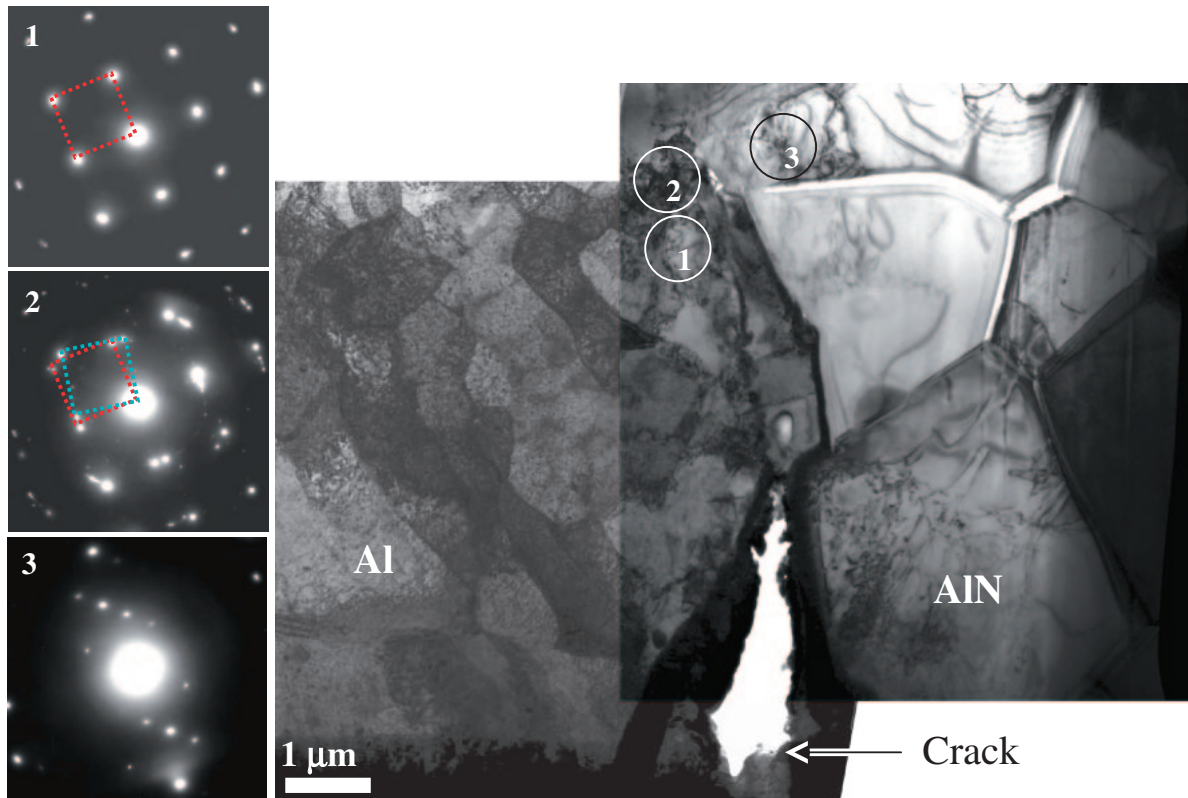
Fig. 12 Diffraction patterns and bright field image around the tip of crack in Al layer. Region 1 and 2 were Al layer. Region 3 was AlN layer.

Figure 12 shows a TEM image of a crack tip near the Al/AlN interface and diffraction patterns from region 1, 2 (Al layer) and 3 (AlN layer), respectively. The grain size near the crack tip is found to be approximately $1\ \mu\text{m}$ or less. The result agrees with that estimated from the AsB image of Fig. 9. The diffraction pattern revealed that grains in region 1 and 2 are aligned in almost the same direction but with a small twisting. The bright field image indicates that Al grains in region 1 are divided into sub-grains by formation of sub-boundaries due to accumulation of dislocations.
