# Vulnerability Assessment on Non-Engineered Building in Earthquake Prone Area. Case Study: Klaten District, Central Java, Indonesia

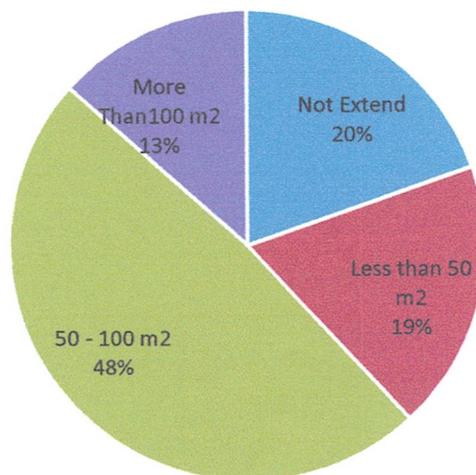
Figure 4. Buiding Size Information

In 2017 an analysis of changes in the area that occurred in 100 houses was given funding to build houses after the 2006 earthquake. Figure 4 shows the percentage of people changing the condition of the building after 12 years of wider earthquakes. Only 20% of houses do not change the structure of the building so that it remains in accordance with the predetermined design. Whereas 19% of the houses have been added to the area of less than 50 m<sup>2</sup>, the addition of areas ranging from 50 to 100 m<sup>2</sup> is around 48% and the addition of area above 100 m<sup>2</sup> is 13%.

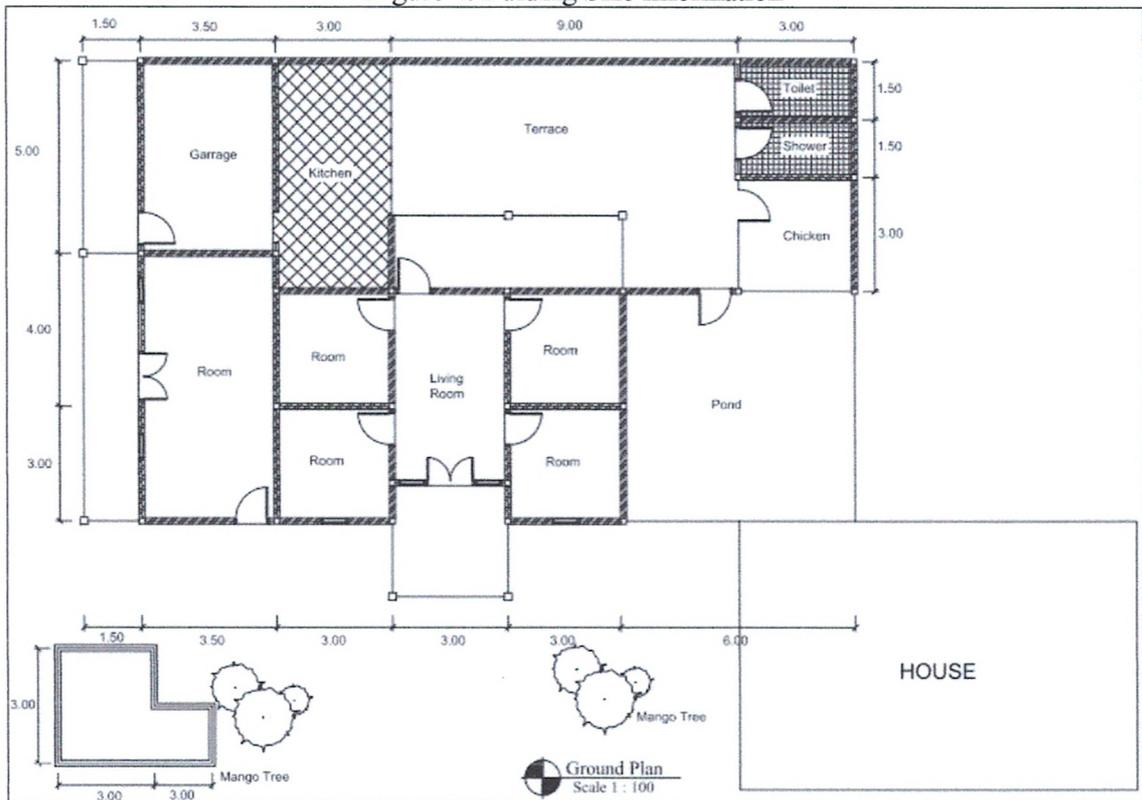
Figure 5. Example building with increase the size

In Figure 5 is a plan of one of the buildings that has increased the area. The building was built without using earthquake resistant building rules as regulated by the local government. So that it is necessary to do further examination regarding the level of vulnerability of buildings to

earthquake forces that can occur without predictions beforehand. In addition, the addition of non-permanent extension material is also one of the most widely used components.
