# Detection of Pavement Surface Crack Based on Image Processing using Wavelet Features Extraction Technique

**Abstract** Evaluation of road pavement is an important part of maintaining its quality. In a traditional way, human checks the asphalt by walking along the road. This traditional method it is less efficient because it requires substantial costs, takes a long time, exposed to safety issues such as the high intensity of vehicle passing by, the subjective factor, and the fatigue factor. With digital image processing technique, pavement evaluation will be safer for surveyor. Pavement's cracks are captured on a picture and then processed with some algorithm. This paper explains the principle of Discrete Wavelet Transform (DWT). The image is filtered by the low-pass filter and a high-pass filter and decomposed into four sub-bands to perform feature extraction to extract unique features of the picture. These extracted features are then applied to classification method using linear discriminant analysis (LDA), and the accuracy is about 92.8%.

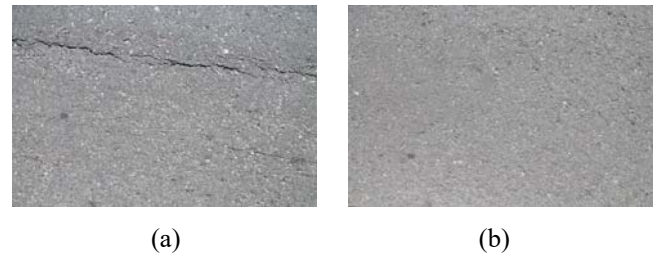
Middle-quality images have cracked that less obvious, so it is difficult to recognise because have almost the same colour between object and background and non-crack images displays a less smooth. The sample of middle-quality images is shown in Figure 8

**Figure 8.** Middle quality images (a) crack, (b) non-crack

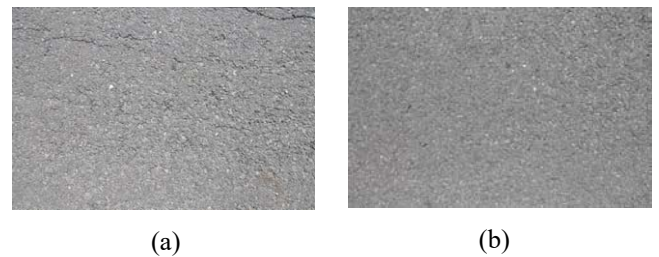
Bad quality images are images that can't be processed properly and produce a false decision according to manual classification. This image isn't clear with the same colour between object and background, so it's difficult recognised. The sample of bad quality images is shown in Figure 9

**Figure 9.** Bad quality images (a) crack, (b) non-crack
