## Research Article

# Experimental Assessment of Rebar Corrosion in Concrete Slab Using Ground Penetrating Radar (GPR)

Corrosion of steel reinforcement is a major cause of structural damage that requires repair or replacement. Early detection of steel corrosion can limit the extent of necessary repairs or replacements and costs associated with the rehabilitation works. The ground penetrating radar (GPR) method has been found to be a useful method for evaluating reinforcement corrosion in existing concrete structures. In this paper, GPR was used to assess corrosion of steel reinforcement in a concrete slab. A technique for accelerating reinforcement bar corrosion using direct current (DC) power supply with 6% sodium chloride (NaCl) solution was used to induce corrosion to embedded reinforcement bars (rebars) in this concrete slab. A 2 GHz GPR was used to assess the corrosion of the rebars. The analysis of the results of the GPR data obtained shows that corrosion of the rebars could be effectively localized and assessed.

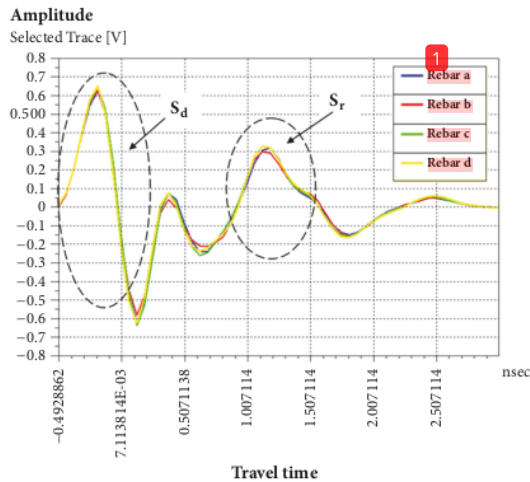
FIGURE 11: *a*-scan of the postcorrosion slab before accelerated corrosion.

**4.2. Assessing Rebar Corrosion Using GPR.** Figure 11 shows the *a-scan* of line 25 before the accelerated corrosion process. The line is used as a reference because line 25 is in the middle of the rebar and also represents the condition of the rebars. Rebars a, b, c, and d are conditions of rebars which agree with information contained in Table 1. In Figures 11–14,  $S_d$  refers to the direct wave signal and  $S_r$  is the reflected wave signal from the rebar-concrete interface. There are no significant differences in the waves peak (i.e., direct wave and reflected wave) in terms of amplitude and travel time for all four rebars, which indicates that the rebars are in good condition (no corrosion). The waves are very important for reinforced concrete durability as it can provide information on concrete cover, i.e., the thickness and quality (presence of defects) of the concrete cover [53]. Information on the wave peaks is shown in Table 2.

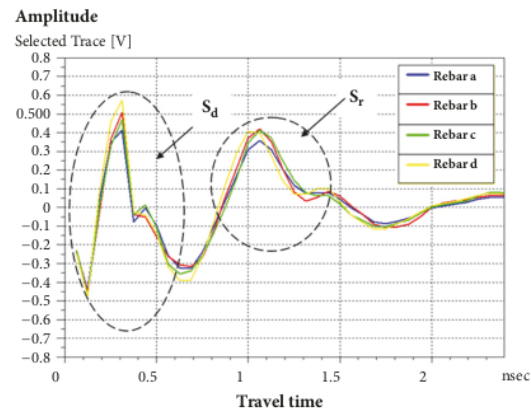
FIGURE 12: *a*-scan of the postcorrosion slab after accelerated corrosion of rebar b.

Figure 12 shows the *a-scan* of the concrete slab at line 25 after the completion of the corrosion process of rebar b at the 21st day. Table 3 provides information on the quantification of the *a-scan* shown in Figure 12. The amplitude of direct wave and reflected wave peak was increased because the frequency was attenuated due to the accelerated corrosion [34, 53, 54]. The amplitudes of rebars b, c, and d were higher than that of rebar a. These conditions could be caused by the

high content of chloride [35]. This may happen after cracking of the concrete cover, allowing faster ingress of chloride ions to the rebar; however prior to cracking hardly any chloride ions were present near the rebar. In this condition,

chloride ions were forced to accumulate around the rebar. The accumulation of ions attenuated and absorbed the reflected wave in both time and frequency.

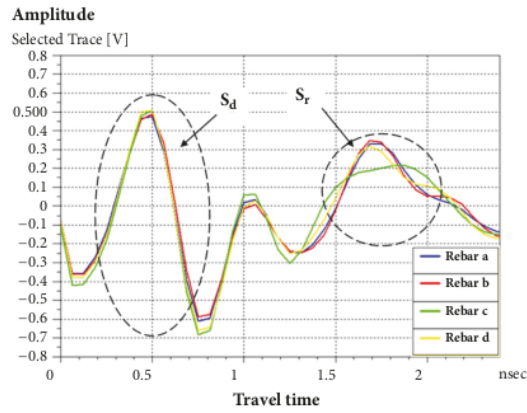
FIGURE 13: *a*-scan of the postcorrosion slab after accelerated corrosion of rebar c.

Figure 13 shows the *a*-scan of the concrete slab at line 25 after the completion of the corrosion process of rebar c at the 55th day. The frequencies of the waves shift to lower regime due to the effect of the corrosion process. The reflected waves of rebar c have lower amplitude than that of rebars a, b, and d because it is likely that the corrosion process of rebar c was affected by the accumulation of chloride ions in the concrete cover zone of the rebar which is more than for the other rebars. The higher content of chloride ions retarded and absorbed the waves in both time and frequency [55, 56]. The quantification values of the waves are shown in Table 4.

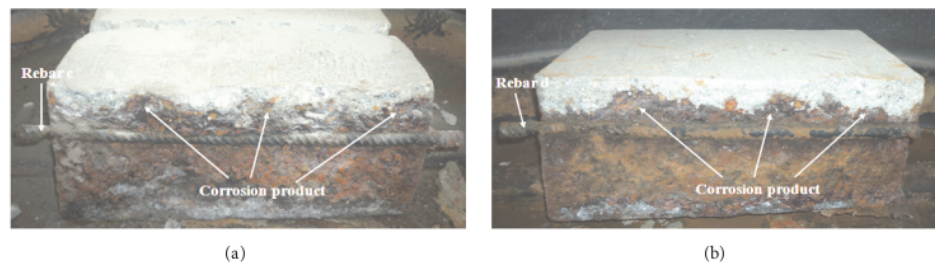
FIGURE 16: Cut sections of the postcorrosion slab: (a) rebar c and (b) rebar d.

(Figure 16(b)) have not diffused significantly to the concrete cover surface like the corrosion products of rebar c, as shown in Figure 16(a).
