Changes in Microstructure of Al/AlN Interface during Thermal Cycling

Yoshiyuki Nagatomo¹, Takeshi Kitahara¹, Toshiyuki Nagase¹,
Yoshirou Kuromitsu¹, Harini Sosiati² and Noriyuki Kuwano³

¹Central Research Institute, Mitsubishi Materials Corporation, Naka 311-0102, Japan

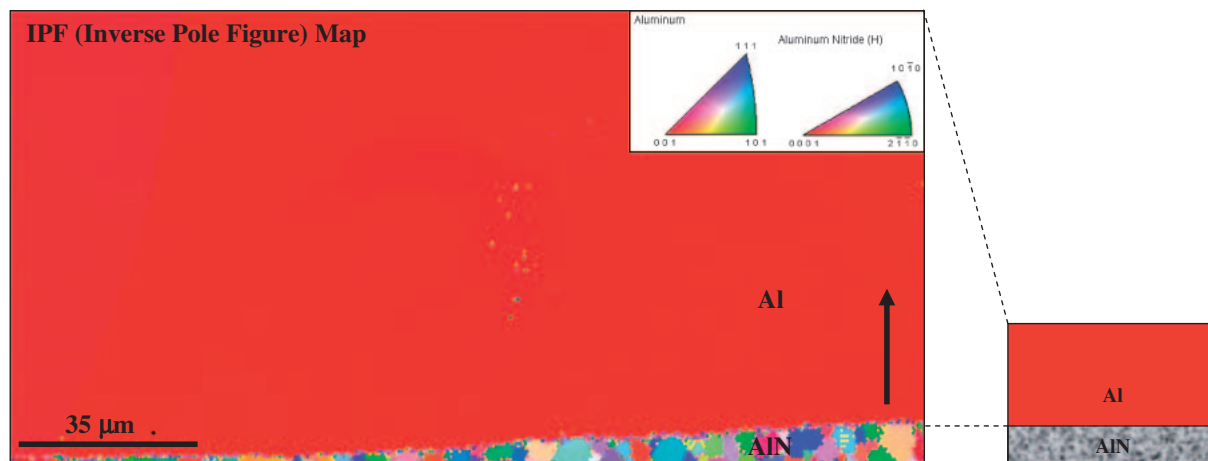
Fig. 2 IPF map of Al/AlN interface before thermal cycle test. The arrow shows the direction to identify crystal-orientations of the Al layer.

Figure 2 shows an inverse pole figure (IPF) map obtained with EBSD analysis around Al/AlN interface before thermal cycling. It explains crystal-orientation of Al along normal direction of Al/AlN interface. It is revealed that $\langle 001 \rangle_{\text{Al}}$ directions of most Al grains were oriented in the normal direction of Al/AlN interface. The result is consistent to

the fact that cube-oriented grains are grown preferentially with a heat treatment in rolled Al with over 99.99% purity.⁵⁾ The grain size of cube-orientated Al was found to be approximately 0.6–1.0 mm. One cannot distinguish clearly a border between the Al brazed layer and pure Al by the difference in crystallographic-orientation. This suggests that the Al-Si brazing sheet once melted was solidified with an epitaxial relationship with the Al-plate having cube orientation.

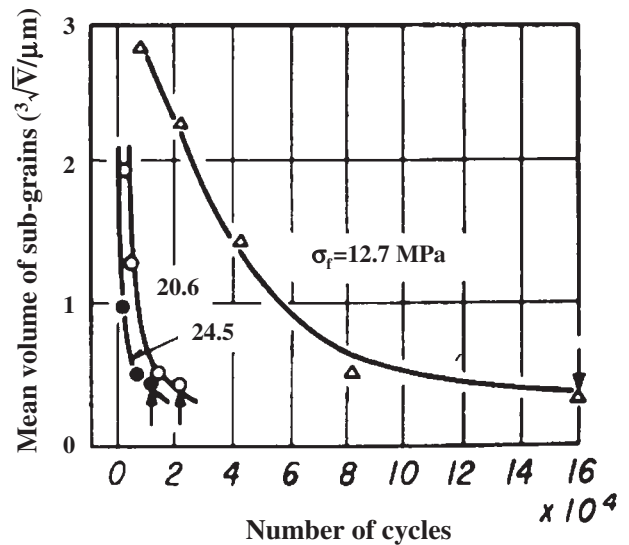
Figure 13⁶⁾ shows variations of sub-grain size of Al with a repeated tension-compression test. It is found that the sub-grain size of Al decreases as the number of cycles increases. In addition, the grain size of Al around a fatigue crack tip after the repeated tension-compression test remained constant to be $1\ \mu\text{m}$ or less, despite a change of an alternating stress. The result supports that the formation of a crack in the Al layer is attributed to fatigue fracture. Because the fatigue crack in Al is formed when the grain size approach a critical size ($1\ \mu\text{m}$ or less), pinning of dislocations with the Si particles in the Al layer observed in Fig. 10 would be effective to prevent the fatigue fracture by hindering the progress of the refinement of Al grains.

Fig. 13 Variation of sub-grain size of Al with alternating stress (σ_f) and number of cycles. The arrows show the points of crack generation.⁶⁾
