# Vulnerability Assessment on Non-Engineered Building in Earthquake Prone Area. Case Study: Klaten District, Central Java, Indonesia

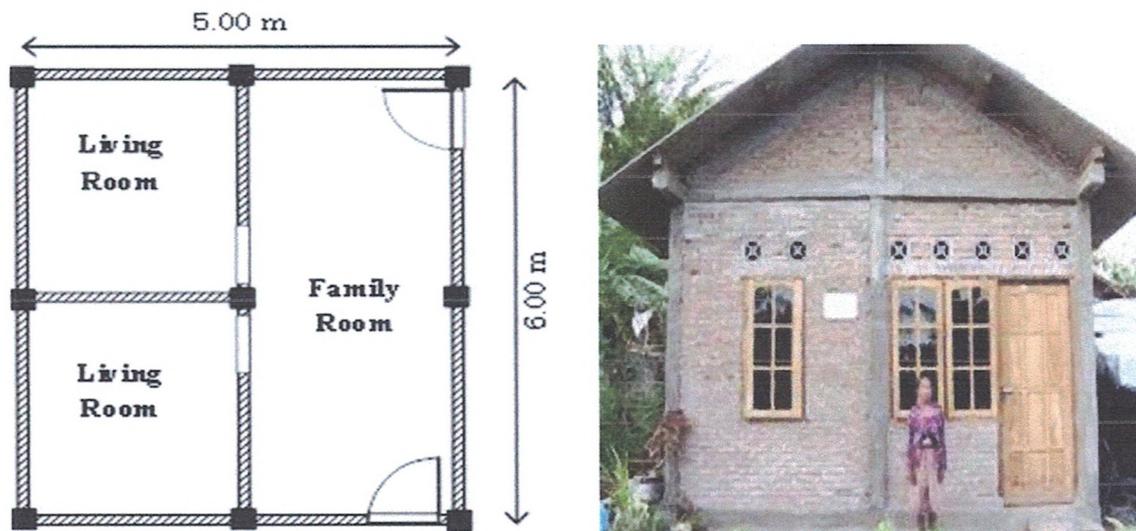
Figure 1. The initial design and shape of the building's initial construction in 2006

In this study, we will examine houses built after earthquakes. At the beginning of its construction, the house was built on the condition of earthquake resistant buildings as shown in Figure 1. As time went on, the level of change that occurred in the 100 buildings will be checked. Next will be an examination of the level of building vulnerability both in terms of structural and non-structural components. The components examined were structural components, wall conditions, roof conditions, horizontal and vertical vulnerabilities.

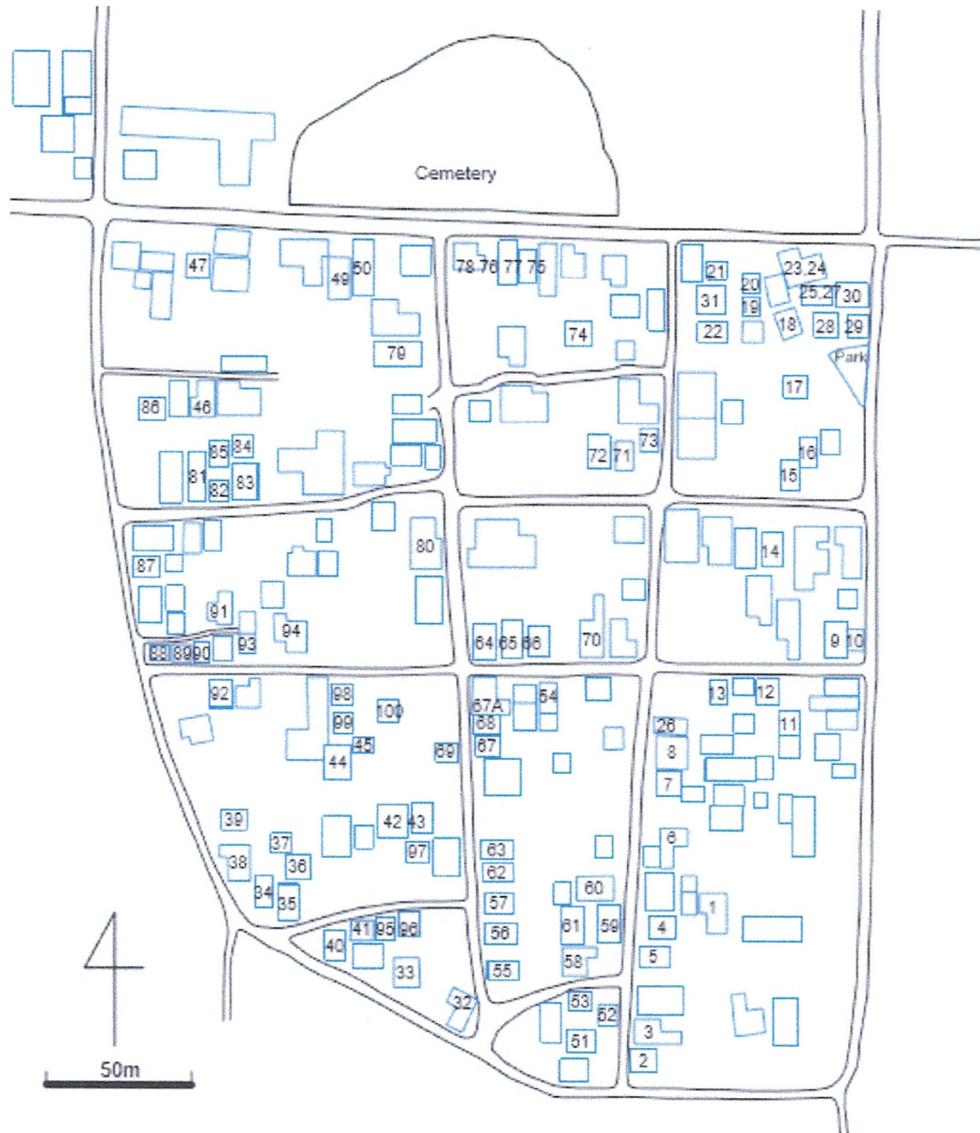
**Figure 2.** Plan location inspection and the number of positions of the building under study

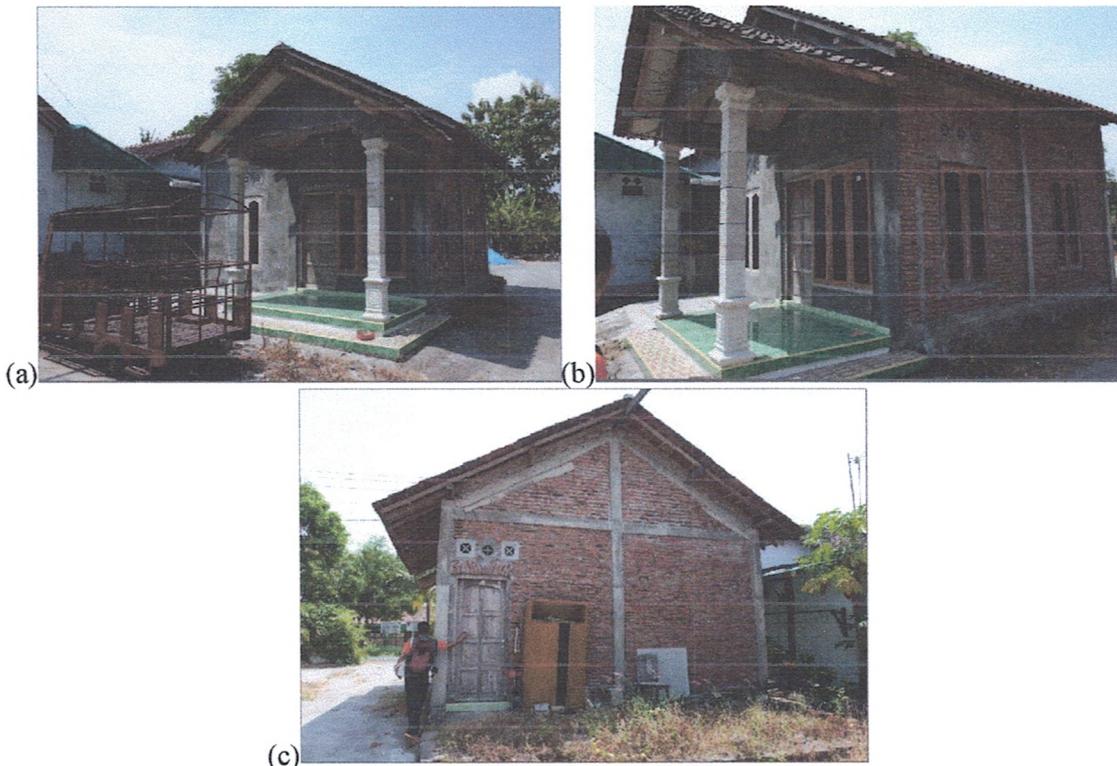
structures that have been designed to withstand earthquake loads. The house sample according to the rules can be seen in Figure 3. The size of the building used in 2006 was 5 x 6 m.

Figure 3. Reconstruction result after earthquake in 2006 until 2007
