# Road Surface Crack Detection using Wavelets Features Extraction Technique

Slamet Riyadi<sup>1\*</sup>, Fiddin Yusufda A'la<sup>1</sup>, Chayadi Oktomy<sup>1</sup> and Kamarul Hawari Ghazali<sup>4</sup>

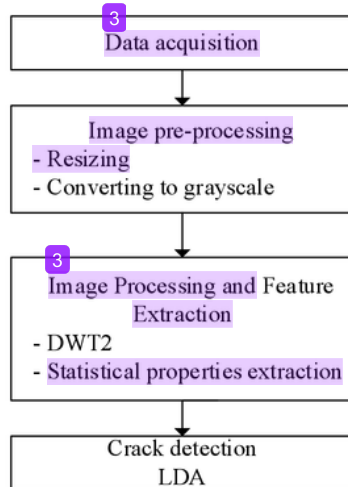
Figure 1. Crack detection diagram.

The methodology of the research is described in Figure 1. Firstly, to get the images data, we have to make data acquisition. Then the data was resized and converted to grayscale image. After that, images are processed and extracted using statistical properties extraction. This

study used mean and standard deviation values as statistical properties extraction. Finally, the linear discriminate was applied to classify the images as “crack” or “non-crack”. Discriminate lines make images separated by its class. This result was then compared to visual initialization images to get the percentage of accuracy.

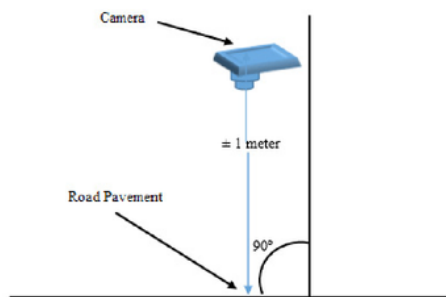
Figure 2. The image acquisition setup.

Figure 2 shows the image acquisition setup according to the following protocols:

- The camera was positioned in perpendicular view to the road.
- Camera and road surface distance should not be too close or too far so the image obtained can be processed well.
- Data was collected at certain hours when it is not too dark and have enough light intensity.

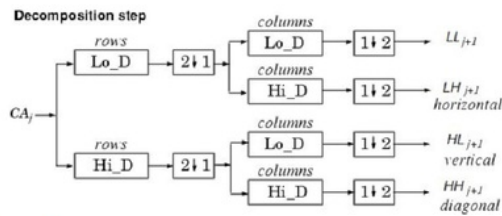
Figure 4. Decomposition step.

If an image transformations process is carried out with two-dimensional discrete wavelet decomposition level one as shown in Figure 4, it will generate four sub-bands, namely:

- Coefficient Approximation (CA) or LL sub-band.
- Coefficient Horizontal Detail (CH) or HL sub-band.
- Coefficient Vertical Detail (CV) or LH sub-band.
- Coefficient Diagonal Detail (CD) or HH sub-band.

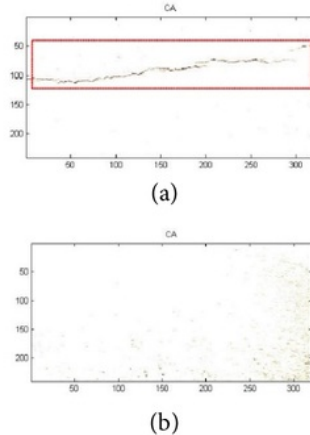
Figure 5. CA transformation result (a) crack images (b) non-crack images.

This algorithm has been applied and produced CA values after decomposition as shown in Figure 5.

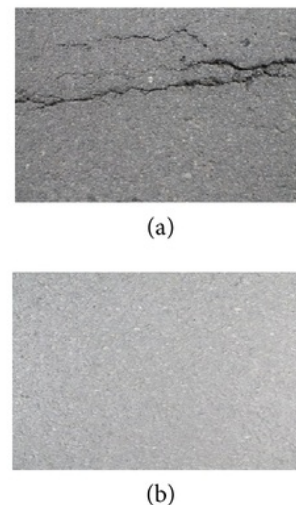
Figure 7. Good quality images (a) crack, (b) non-crack.

A total of 56 testing images were classified by quality into good, medium, and low. This qualification based on manual perception. Good quality images are images that can be processed properly and produce a right decision according to manual classification. It is easy to detect because the images have a high contrast between object and background. The sample of good images is shown in Figure 7.

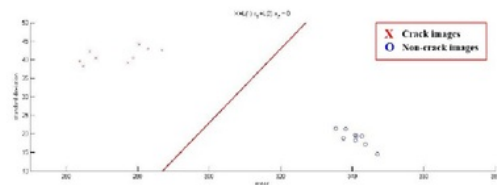
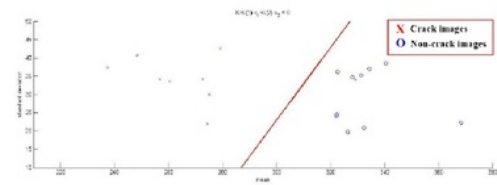
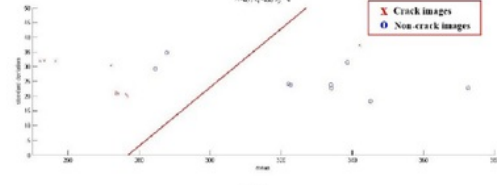
Figure 10. Scatter plot of tested images by quality, (a) good, (b) medium, (c) low.

These images were tested using linear discriminant analysis. The result of tested images is shown in Figure 10.

Scatter plot result quality images are shown in Figure 7 with "x" as crack images and "o" as non-crack. From scattering plot result can be observed that both of crack and non-crack images separated by red lines linear equation. It's mean that testing on good quality images Figure 7(a) scores up to 100% accuracy. Scatter plot of medium-quality images Figure 7(b) can be observed that some

images cross the red lines equation, scores up to 94.7% accuracy. Scatter plot of bad quality images Figure 7(c) can be observed that some images cross the red lines. This type crack and non-crack images difficult to distinguish from the background scores up to 94.7% accuracy. The classification results of 56 testing images filtered by quality; good, medium, and low quality which shown in Table 1.
